**Flood Control Project Maintenance
Levee Inspections**
LMA District Cover Sheet
Spring 2014 Levee Inspection Results

Reclamation District No. 0501 Ryer Island

Spring 2014 Levee Inspection Results

Waterway			Bank	Unit Miles
Unit No. 01 Steamboat Slough			Right	6.76
	Spring (March - May)	Summer (June - August)	(September - November) Fall	Winter (December - February)
Unit Maintenance Rating (Fall Only)				
Date of Inspection	04/02/2014 - 04/02/2014			
DWR Inspector	Herman Phillips			
Accompanied By	Niclas Zepeda RD 501

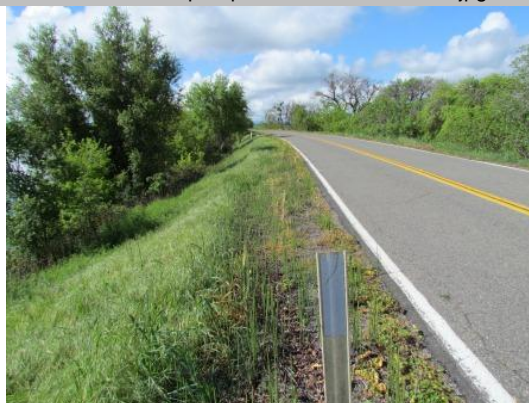
Photo 1 of 1 : phillips_s_20140527_05970.jpg

RD 501 Looking downstream from levee mile 0.02 waterside.

LM Start	0.02	Rating **	U	Issue No.	120
LM End	0.03	Issue Type +	Ma	Location *	LS
Category	Earthen Levee			GPS Latitude/Longitude	
				Start	End
Item	Vegetation			38.254089 °	38.254023 °
				-121.601732 °	-121.601853 °
DWR ID	DWR_RD0501_01_f_2013_120				
Action/Comments					
Trees / Woody Vegetation					
Inspector Comments: This growth of fig trees should be removed from landward toe of levee and slope, visibility is completely blocked.

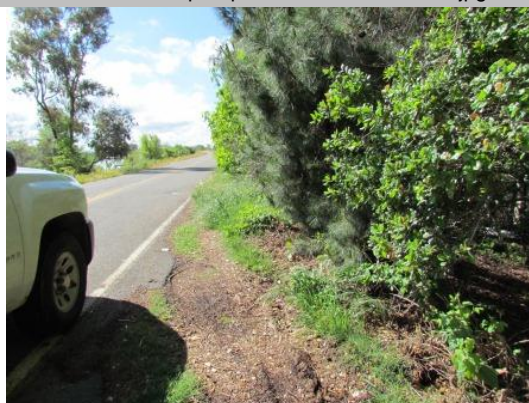
Photo 1 of 1 : phillips_s_20140527_05971.jpg

Unsatisfactory woody growth blocking the visibility of the levee section.

LM Start	0.03	Rating **	M	Issue No.	2
LM End	0.03	Issue Type +	Ma	Location *	WS
Category	Earthen Levee			GPS Latitude/Longitude	
				Start	End
Item	Vegetation			38.254075 °	38.254025 °
				-121.601838 °	-121.601928 °
DWR ID	DWR_RD0501_01_s_2012_2				
Action/Comments					
Remove the wild growth other than native grasses from the levee slopes.

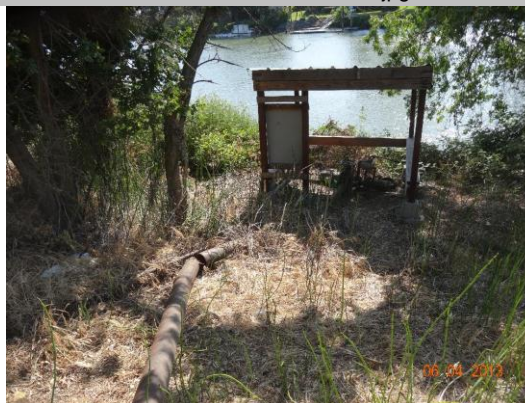
Photo 1 of 1 : UCIP_2484.jpg

LM Start	0.17	Rating **	M	Issue No.	44
LM End	0.17	Issue Type +	En	Location *	LS
Category	Supplemental			GPS Latitude/Longitude	
				Start	End
Item	DWR UCIP Field Study			38.252140 °	38.252140 °
				-121.602902 °	-121.602902 °
DWR ID	DWR_RD0501_01_s_2014_44				
Action/Comments					
Inspector Comments: FS_ID:21208					
EP_NO: 4581					
Repair Type:					
Crossing Status:					
UCIP Comments: Damage present from leaky pipe. Signs of repair work on crown, however, no permit found to document recent damage to levee or repair work. New PVC pipe has been sleeved through the existing 6-inch pipe. Unable to determine if crossing is still in use, if not, crossings needs to be removed according to CVFPB Title 23 requirements.					
FIELD_STRUCT_DESC: 6-inch steel pipe through the levee, 2.5 feet below the crown. 2-inch steel electrical conduit through levee. Cutoff wall around pipe at center of levee. Pump and gate valve in pump structure on waterward slope. Service pole on landward slope. Pipe exposed on both slopes. (Permit No. 4581-1964)

Overview of waterward side--pump, abandoned pipe section, and conduit.

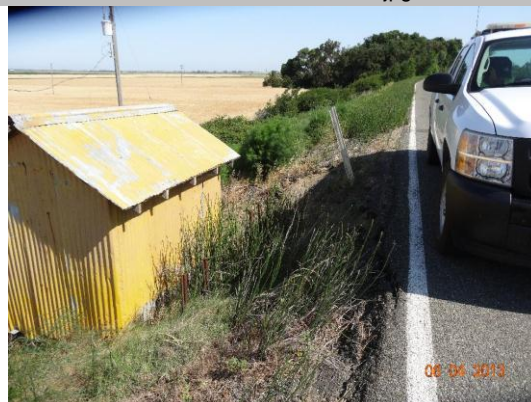
Photo 1 of 1 : UCIP_1697.jpg

LM Start	0.38	Rating **	M	Issue No.	45
LM End	0.38	Issue Type +	En	Location *	LS
Category	Supplemental			GPS Latitude/Longitude	
				Start	End
Item	DWR UCIP Field Study			38.249185 °	38.249185 °
				-121.603036 °	-121.603036 °
DWR ID	DWR_RD0501_01_s _ 2014_45				
Action/Comments					
Inspector Comments: FS_ID:18503					
EP_NO: N/A					
Repair Type:					
Crossing Status:					
UCIP Comments: Dense vegetation limits the inspector's visibility to identify signs of leaks through the slope. Recommend removing vegetation along pipe alignment for reinspection. Need to contact the owner for maintenance and to obtain permit number issued for crossing.					
FIELD_STRUCT_DESC: 20-inch and 2.5-inch pipes through the levee, both 7.8 feet below the crown. Pump in pump house on landward slope. Pipe exposed along waterward slope. (USACE-1959). This entry matches the Drainage or Irrigation Structure referenced in O&M manual (HLM 0.40).

Overview of landside. Pump house and power pole visible on landward side.

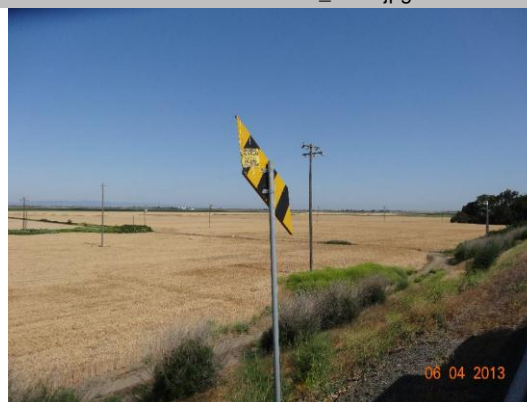
Photo 1 of 1 : UCIP_1700.jpg

LM Start	0.43	Rating **	M	Issue No.	46
LM End	0.43	Issue Type +	En	Location *	LS
Category	Supplemental			GPS Latitude/Longitude	
				Start	End
Item	DWR UCIP Field Study			38.248519 °	38.248519 °
				-121.602972 °	-121.602972 °
DWR ID	DWR_RD0501_01_s_2014_46				
Action/Comments					
Inspector Comments: FS_ID:18504					
EP_NO: N/A					
Repair Type:					
Crossing Status:					
UCIP Comments: Need to contact owner and ask for emergency contact information and permit number. 6/21/13 Contacted Gas Control Division under the emergency contact No. 1-877-723-3344. Message has been forward to Brian Habersack at 916-859-4700, email: bhabersack@gasbiz.com.					
FIELD_STRUCT_DESC: Gas line crosses the levee at an angle. Markers visible on both shoulders.					
FS Date: 6/4/2013

Overview of landside at crossing. Marker on shoulder.

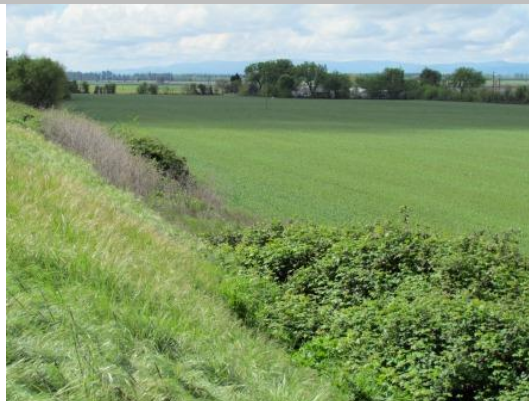
Photo 1 of 1 : phillips_s_20140527_05962.jpg

Wild growth of unwanted berry vines on the landside ward slope and toe blocking view.

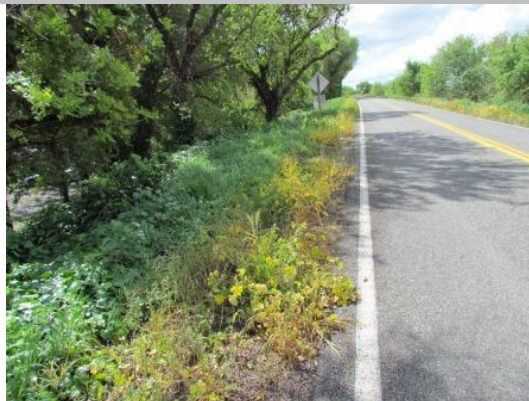
Photo 1 of 1 : phillips_s_20140527_05961.jpg

Unsatisfactory woody tree growth blocking the visibility of waterside levee section.

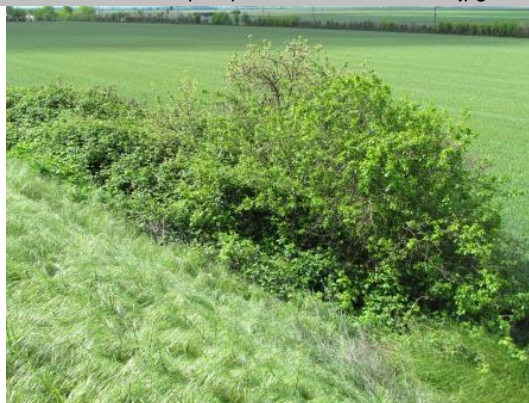
Photo 1 of 1 : phillips_s_20140527_05963.jpg

LM Start	1.02	Rating **	U	Issue No.	126
LM End	1.02	Issue Type +	Ma	Location *	LS
Category	Earthen Levee			GPS Latitude/Longitude	
				Start	End
Item	Vegetation			38.240061 °	38.240061 °
				-121.603925 °	-121.603925 °
DWR ID	DWR_RD0501_01_f_2013_126				
Action/Comments					
Trees / Woody Vegetation

Looking downstream from levee mile 1.02 landside slope and toe unwanted berry vines.

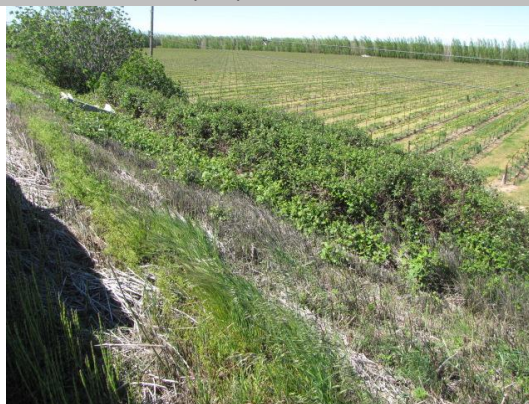
Photo 1 of 1 : phillips_s_20140306_820.JPG

Looking downstream landward slope and toe overgrown with wild berries and horsetail.

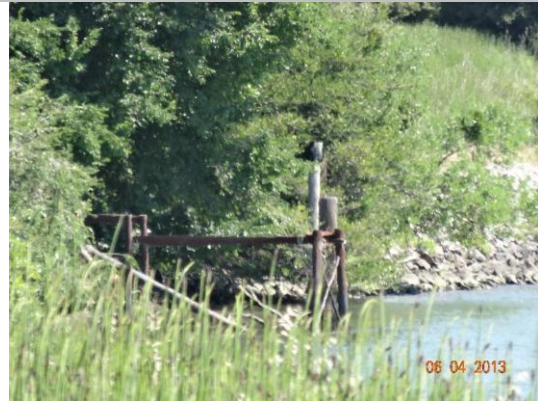
Photo 1 of 1 : UCIP_1907.jpg

UCIP Comments: Dense vegetation limits the inspector's visibility to identify signs of pipe failure (leaks) through the levee slopes.

FIELD_STRUCT_DESC: 16-inch drainpipe through the levee, 3.6 feet below the crown. Cutoff walls around pipe at center of levee. Siphon breaker on apex of pipe at landward shoulder. Pump house on landward shoulder. Pipe discharges into 48-inch pipe with screw gate on landward side. (Permit No. 2742-1959). Repairs made to pipe and a portion replaced, from landward shoulder to discharge end on waterward side, under Permit No. 15380 (1999). Rock revetment placed on waterward slope. Revegetation in progress on waterside.
FS Date: 6/4/2013

Pipeline intake on waterside photo taken from 1000 feet downstream looking upstream.

Recommend removing vegetation along pipe alignment to conduct proper inspection of structure and appurtenances. Additional notes: pump was running during inspection, 16-inch pipe section abandoned on landward side, view of standpipe and support structure on waterward side does not match structure description--need to determine if crossing has been altered.

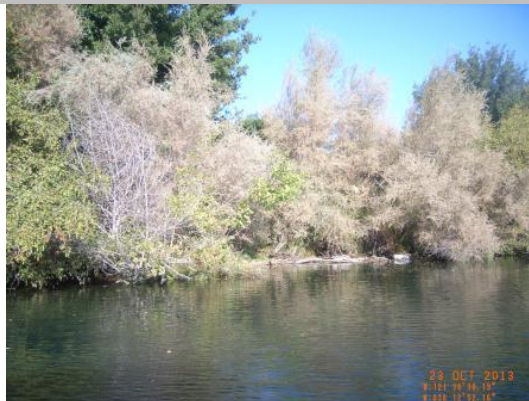
Photo 1 of 1 : USACE2013A_STM_18-9_R_3.jpg

LM Start	2.85	Rating **	M	Issue No.	11
LM End	2.93	Issue Type +	Ma	Location *	WS
Category	Supplemental			GPS Latitude/Longitude	
				Start	End
Item	USACE Erosion Survey			38.214838 °	38.214075 °
				-121.608129 °	-121.608750 °
DWR ID					
Action/Comments					
Inspector Comments: 2009 - Rock is starting to unravel, probably from a tree pop-out, hard toe. 2013: No observed changes. [2013 Site ID: STM_18-9_R]

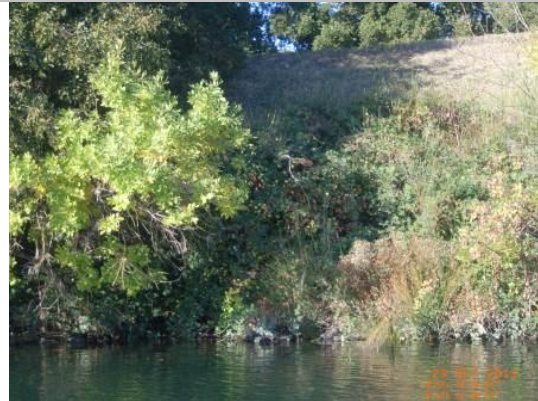
Photo 1 of 1 : USACE2013A_STM_18-8_R_5.jpg

LM Start	3.03	Rating **	M	Issue No.	5
LM End	3.18	Issue Type +	Ma	Location *	WS
Category	Supplemental			GPS Latitude/Longitude	
				Start	End
Item	USACE Erosion Survey			38.212573 °	38.211596 °
				-121.609760 °	-121.609928 °
DWR ID					
Action/Comments					
Inspector Comments: 2000 - Slow erosion of lower and mid-slope with rock bench at the low water line. 2013: No observed changes. [2013 Site ID: STM_18-8_R]

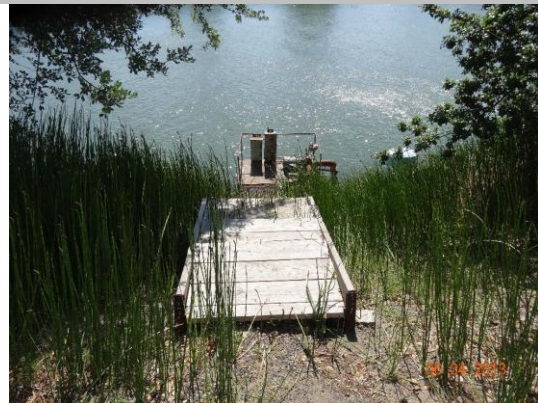
Photo 1 of 1 : UCIP_1866.jpg

LM Start	3.14	Rating **	M	Issue No.	54
LM End	3.14	Issue Type +	En	Location *	WS
Category	Supplemental			GPS Latitude/Longitude	
				Start	End
Item	DWR UCIP Field Study			38.211361 °	38.211361 °
				-121.610178 °	-121.610178 °
DWR ID	DWR_RD0501_01_s_2014_54				
Action/Comments					
Inspector Comments: FS_ID:19584 EP_NO: N/A Repair Type: Crossing Status: UCIP Comments: Damage present to pipe (leak)--recommend conducting test to determine integrity of pipe wall (video, pressure, or other test). Additional notes available: 8-inch is leaking on landward side--white sealant and rag used to seal hole, single line crack on the crown of the alignment, pipe through the levee could be bigger than 8-inch unable to confirm. Also found 3-inch steel pipe approximately 7 feet upstream from 8-inch pipe (authorized or unauthorized?). FIELD_STRUCT_DESC: 8-inch steel pipe and 1.5-inch steel electrical conduit through the levee, both 2.0 feet below the crown. Gate valve on waterward side. Cutoff wall around pipe and conduit at center of levee. Siphon breaker on apex of pipe at landside shoulder. Pump on piling structure on waterward slope installed under Permit No. 9880 (1975). Meter pole at landward toe. Pipe exposed along landward slope. Discharge filter on landward slope installed under Permit No. 9880-B (1975). FS Date: 6/4/2013

Station details--gate valve, air vent, and other appurtenances.

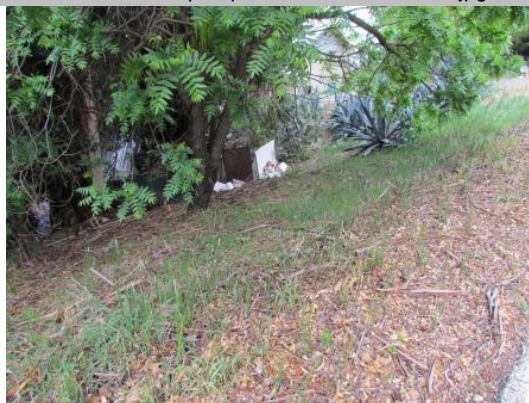
Photo 1 of 1 : phillips_s_20140527_05964.jpg

Woody tree growth on landward slope and toe.

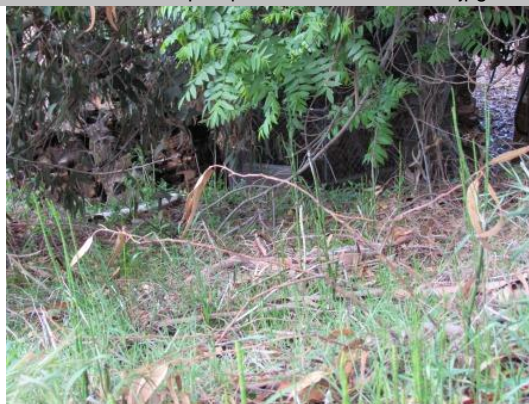
Photo 1 of 1 : phillips_s_20140527_05965.jpg

LM Start	3.20	Rating **	M	Issue No.	15
LM End	3.24	Issue Type +	En	Location *	LS
Category	Earthen Levee			GPS Latitude/Longitude	
				Start	End
Item	Vegetation			38.210429 °	38.209974 °
				-121.610503 °	-121.610703 °
DWR ID	DWR_RD0501_01_s_2012_15				
Action/Comments					
Landscaping

Equipment and other material on slope and toe of levee section.

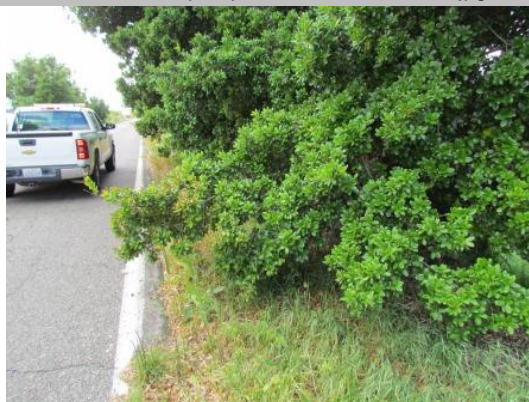
Photo 1 of 1 : phillips_s_20140527_05969.jpg

Woody tree growth on levee slope and shoulder of the landside.

LM Start	3.35	Rating **	M	Issue No.	77
LM End	3.35	Issue Type +	Ma	Location *	LS
Category	Earthen Levee			GPS Latitude/Longitude	
				Start	End
Item	Trim / Thin Trees			38.208390 °	38.208390 °
				-121.611440 °	-121.611440 °
DWR ID	DWR_RD0501_01_s _ 2014_77				
Action/Comments					
Thin trees to allow visibility of the ground and room to flood fight.

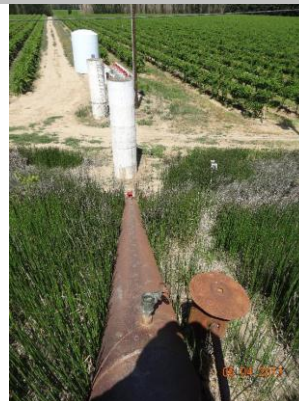
Photo 1 of 1 : UCIP_1707.jpg

LM Start	3.48	Rating **	M	Issue No.	61
LM End	3.48	Issue Type +	En	Location *	LS
Category	Supplemental			GPS Latitude/Longitude	
				Start	End
Item	DWR UCIP Field Study			38.206719 °	38.206719 °
				-121.612098 °	-121.612098 °
DWR ID	DWR_RD0501_01_s_2014_61				
Action/Comments					
Inspector Comments: FS_ID:18624					
EP_NO: N/A					
Repair Type:					
Crossing Status:					
UCIP Comments: Pipe was running during inspection. Crack on crown surface could be associated with pipe vibration during operation.					
Recommend the following: determine owner of crossing, ask owner to clear vegetation along pipe alignment, and obtain maintenance records for crossing.					
FIELD_STRUCT_DESC: 20-inch pipe through the levee, 2.2 feet below the crown. 1.5-inch electrical conduit along side 20 inch pipe. Pump on platform on waterward side. Walkway present on waterward side. Stand pipe located on landward toe. Pipe exposed along both slopes.

Overview of landward slope--siphon breaker on landward shoulder and stand pipe on landward toe.

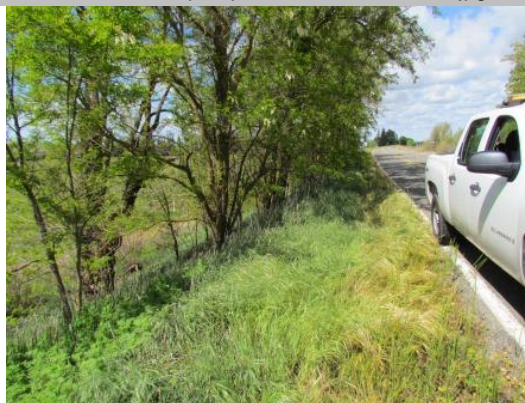
Photo 1 of 1 : phillips_s_20140527_05966.jpg

Looking back upstream from landside slope wild growth of black locus trees on the slope and toe.

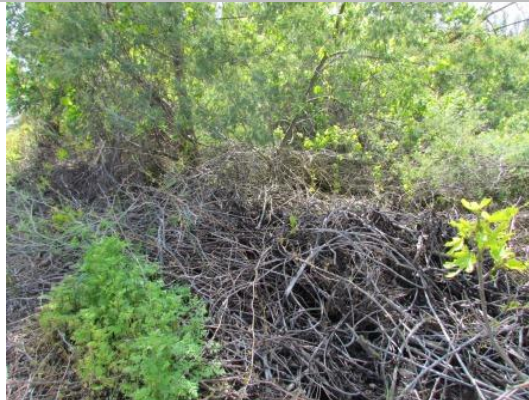
Photo 1 of 1 : phillips_s_20140527_05967.jpg

Unsatisfactory woody growth on the landward slope and shoulder blocking view of levee section.

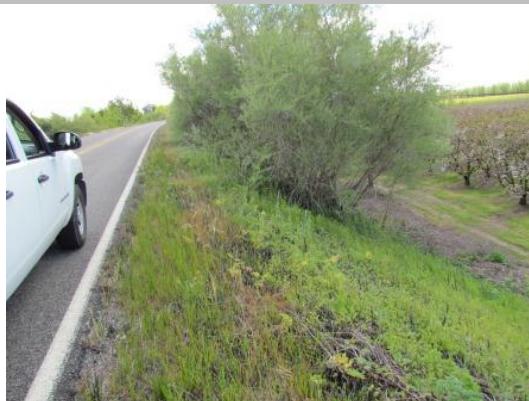
Photo 1 of 1 : phillips_s_20140527_05968.jpg

Woody growth on landside slope looking downstream from levee mile 3.96 to 4.03.

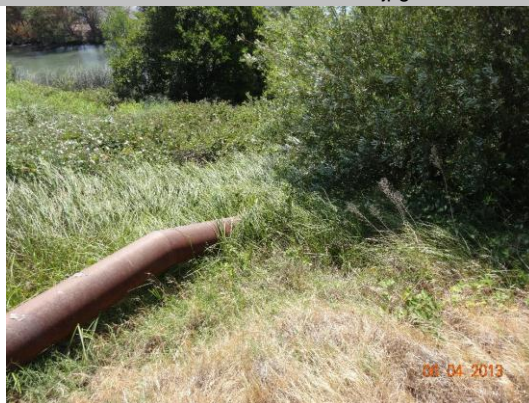
Photo 1 of 1 : UCIP_1909.jpg

LM Start	4.29	Rating **	M	Issue No.	66
LM End	4.29	Issue Type +	En	Location *	WS
Category	Supplemental			GPS Latitude/Longitude	
				Start	End
Item	DWR UCIP Field Study			38.196177 °	38.196177 °
				-121.617899 °	-121.617899 °
DWR ID	DWR_RD0501_01_s _ 2014_66				
Action/Comments					
Inspector Comments: FS_ID:19644					
EP_NO: N/A					
Repair Type:					
Crossing Status:					
UCIP Comments: Pipe section was altered/modified through levee crown. 12-inch pipe sleeved through existing pipe. Dense vegetation limits the inspector's visibility to identify signs of pipe failure (leaks) through the slope. Additional Notes: electrical conduit is disconnected on landside. Recommend removing vegetation along pipe alignment to conduct proper inspection of structure and appurtenances. Also need to contact owner to obtain maintenance records for crossing--need permit authorizing modifications.					
FIELD_STRUCT_DESC: 14-inch pipe through the levee, 3.2 feet below the crown. 12-inch pipe sleeved through existing 14-inch pipe and annular space grouted. 1.5-inch electrical conduit runs parrallel along 14-inch pipe. Pump on pile structure in channel. Walkway to pump. (USACE-1959). This entry matches the Drainage or Irrigation Structure referenced in O&M manual (HLM 4.30).

14-inch steel pipe on waterward side.

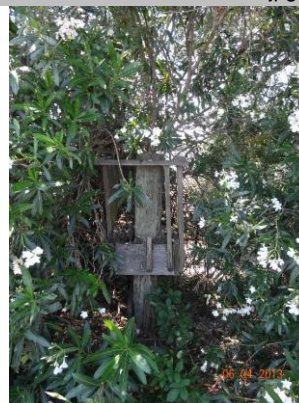
Photo 1 of 1 : UCIP_1914.jpg

LM Start	6.70	Rating **	M	Issue No.	68
LM End	6.70	Issue Type +	En	Location *	WS
Category	Supplemental			GPS Latitude/Longitude	
				Start	End
Item	DWR UCIP Field Study			38.183961 °	38.183961 °
				-121.656860 °	-121.656860 °
DWR ID	DWR_RD0501_01_s_2014_68				
Action/Comments					
Inspector Comments: FS_ID:19645					
EP_NO: N/A					
Repair Type:					
Crossing Status:					
UCIP Comments: Dense vegetation limits the inspector's visibility to identify signs of pipe failure (leaks) through the slope. Recommend removing vegetation along pipe alignment to conduct proper inspection of structure and appurtenances. If structure is trully abandoned--need to find owner to properly abandon crossing.					
FIELD_STRUCT_DESC: Abandoned 16-inch pipe through the levee, 6.5 feet below the crown. Siphon breaker and service pole on landward shoulder. Electrical box on landside toe. Pump on pile stucture in channel.

Electrical box visible on landward toe.

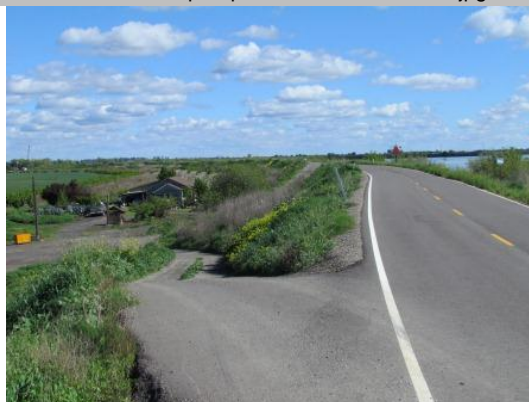
Photo 1 of 1 : phillips_s_20140527_05959.jpg

Tall weeds on landside slope and toe of levee section looking back upstream from levee mile 2.43 to 1.67.

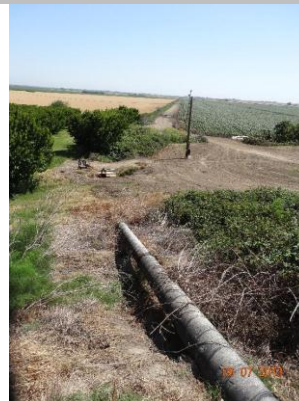
Photo 1 of 1 : UCIP_1958.jpg

View of exposed section of pipe along landward slope. Distribution box and possible closure device located near landward toe.

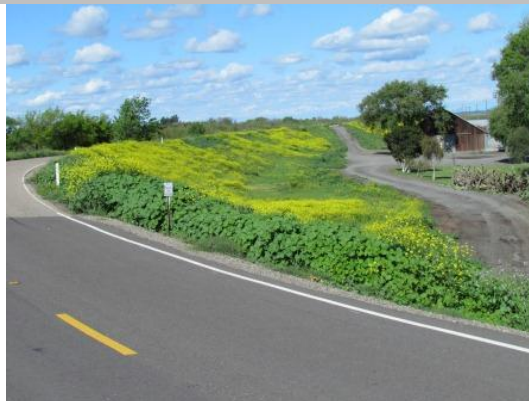
Photo 1 of 1 : phillips_s_20140527_05952.jpg

Unwanted wild growth covering landside slope and toe.

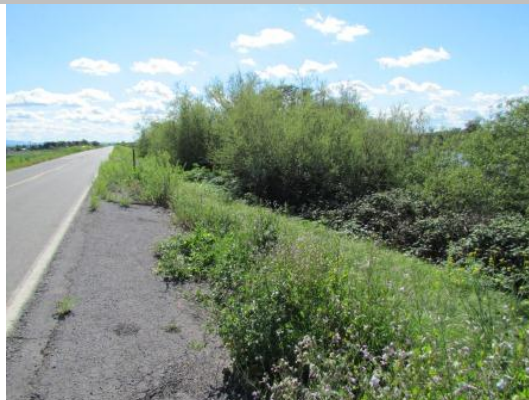
Photo 1 of 1 : phillips_s_20140527_05953.jpg

Unsatisfactory wild growth on waterside slope blocking visibility of the slope and toe.

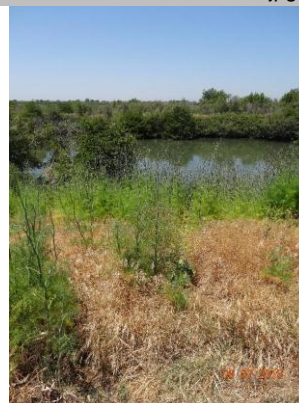
Photo 1 of 1 : UCIP_1981.jpg

Overview of waterward side. Pipe is completely obstructed by dense vegetation.

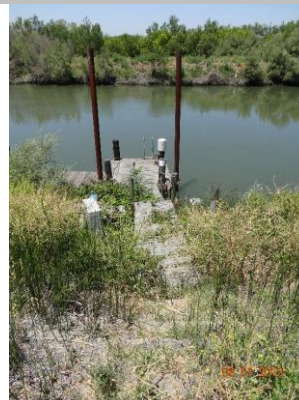
Photo 1 of 1 : UCIP_1988.jpg

View of waterward side. Dense vegetation throughout waterward side.
Walkway visible and support piles.

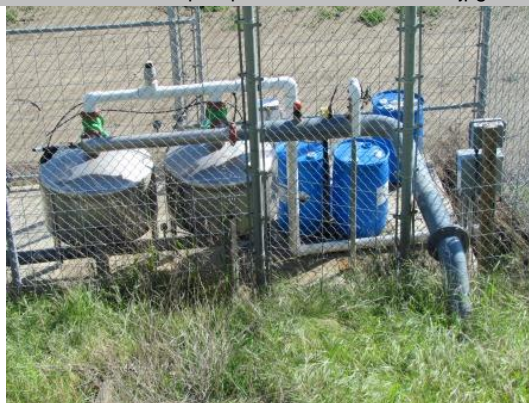
Photo 1 of 2 : phillips_s_20140527_05954.jpg

This filtration system sits within 10-foot of the landward toe, there is no CVFPB Permit on file.

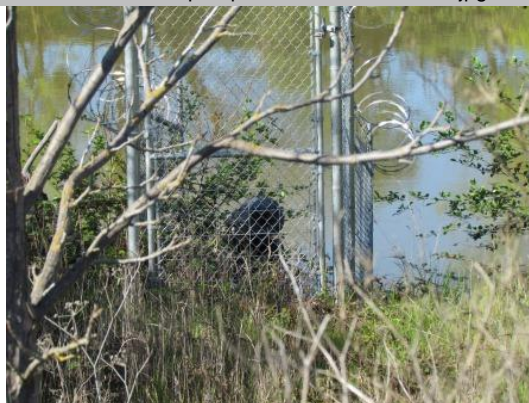
Photo 2 of 2 : phillips_s_20140527_05955.jpg

This photo shows the water side of the pipe and cage.

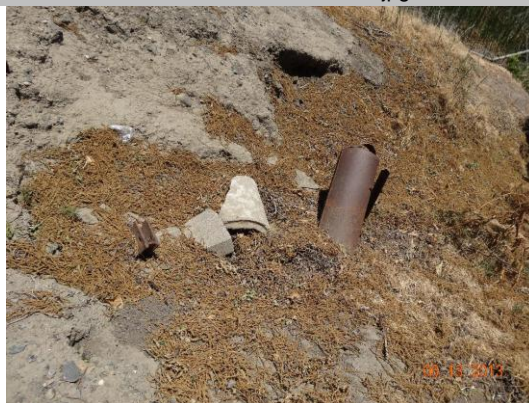
Photo 1 of 1 : UCIP_1894.jpg

Damage metal, concrete, and siphon breaker stand pipe remain on landward shoulder. 8-foot wide damage to levee.

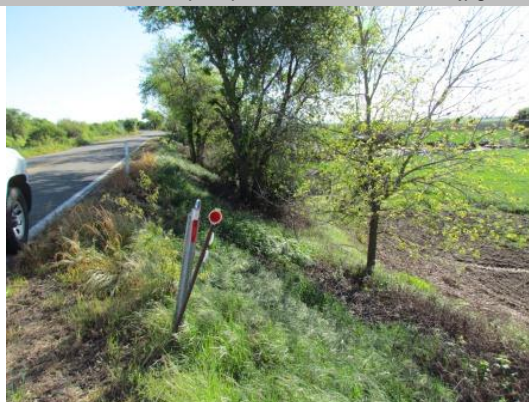
Photo 1 of 1 : phillips_s_20140527_05957.jpg

Wild growth on the landside slope and toe.

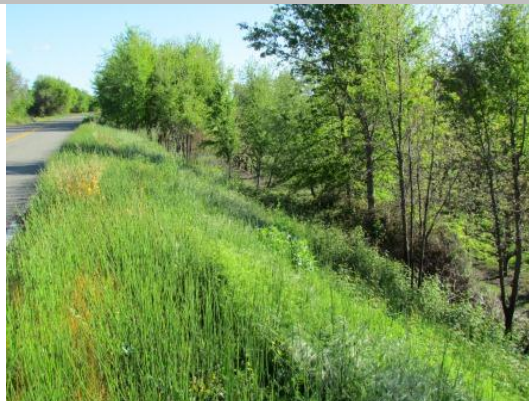
Photo 1 of 1 : phillips_s_20140527_05958.jpg

Wild growth on landward slope and toe.

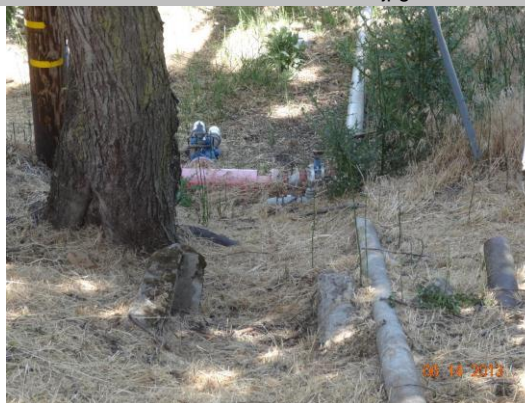
Photo 1 of 1 : UCIP_1887.jpg

Crossing is split in multiple directions. Debris scattered near crossing.
